# Quality Assurance Process Improvement Gas Leak Inspection

## Background

### Project Background:

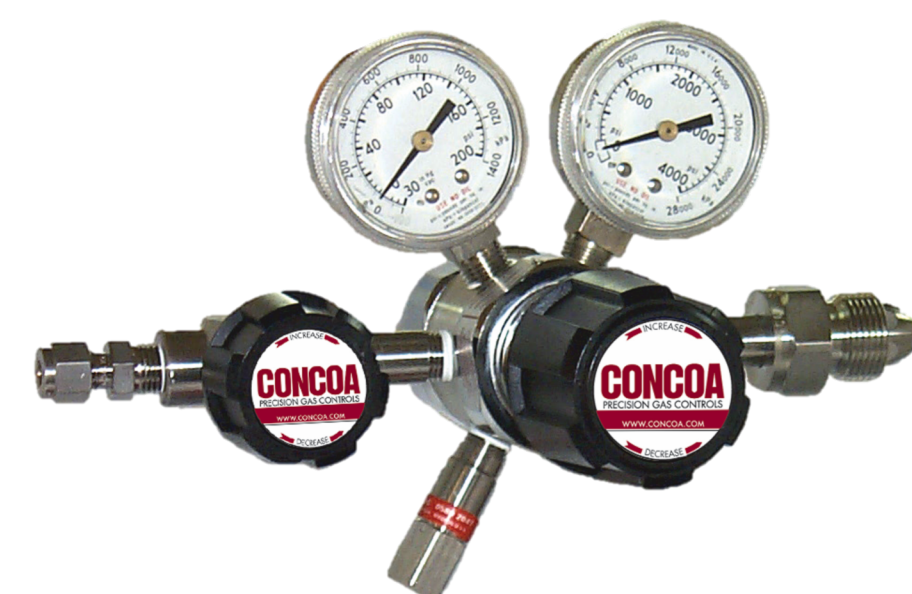
Concoa's regulator product controls the flow of gas between gas sources to applications. Pictured below is a regulator.

Concoa's Regulator

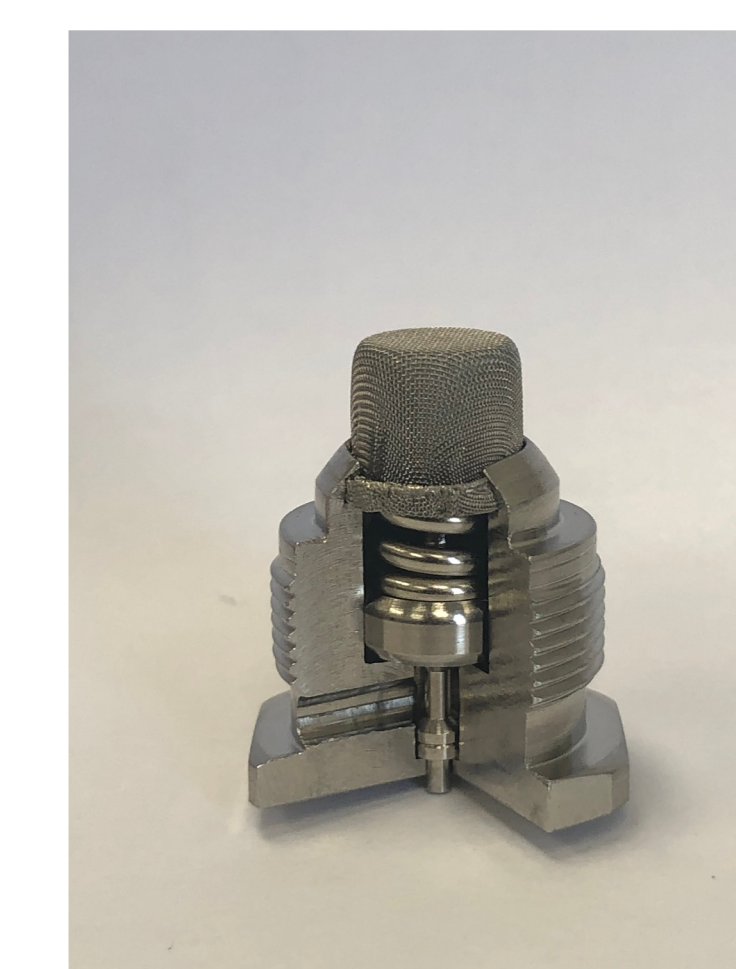
Cross section of ESA
